From The Director's Office:

Utilities—Water

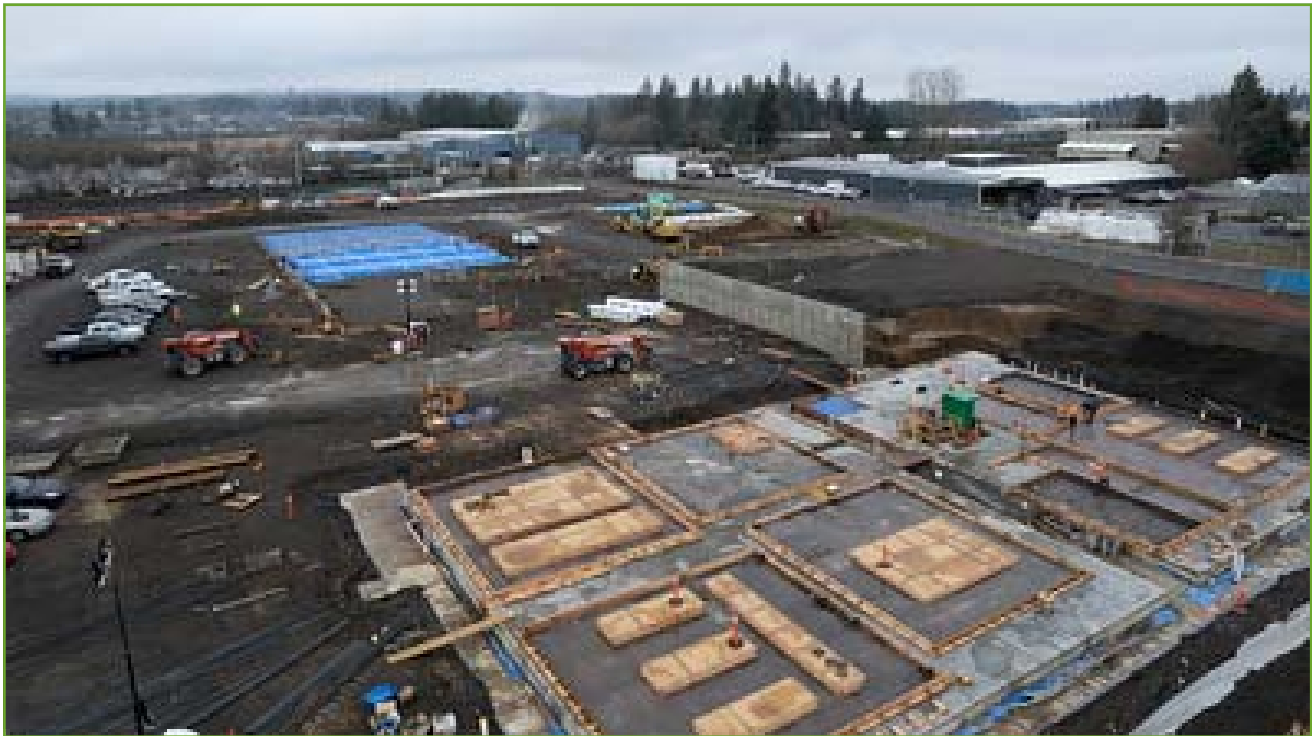
Unique construction techniques are being used in the building of the Public Work Complex. In the bottom right area of the aerial photo below is the foundation of the administration building. The tilt-up wall panel sections for administration building are being constructed on site on top of the foundation slab. A "bond break" material is spread over the concrete slab and then the wall sections are formed with plywood around the edges and blocking out the areas that will become either doors, windows or other wall penetrations. Reinforcement bars are placed in the wall cavity and concrete is poured to fill the form. The face of the wall is finished to a smooth texture and then another layer of "bond break" is spread and second set of wall panel sections are formed and poured. This process is repeated until all the wall sections are created. Once the wall panels concrete is cured then the sections will be pulled up and hoisted by a crane to be set into place around the perimeter of the administration building.

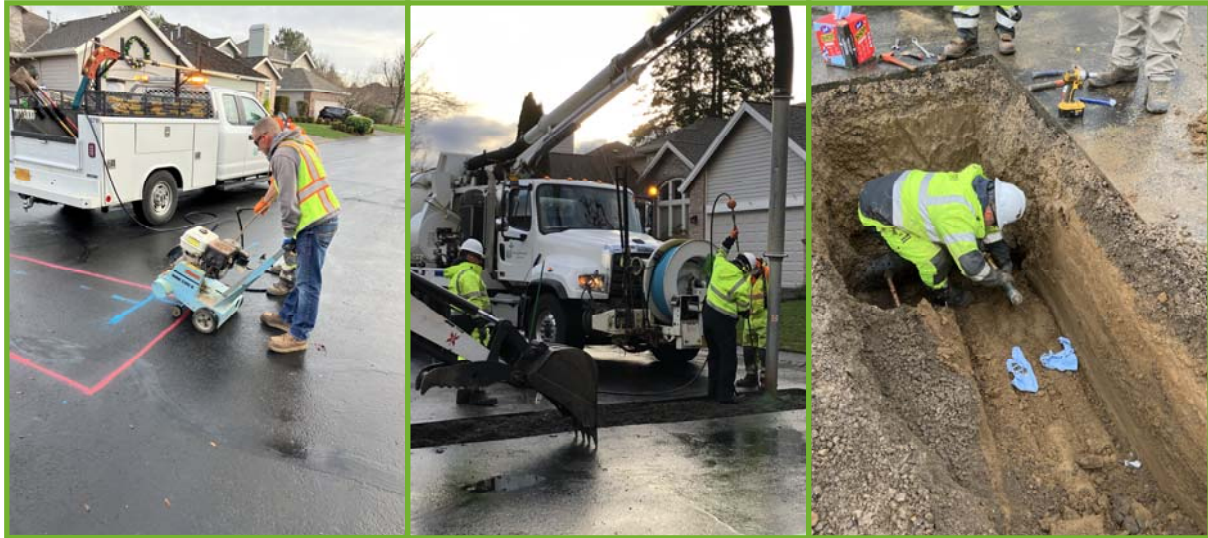
The Utilities crew performed a water main tap to install a new service line for a residence in Charbonneau. When the service line was originally installed, it was configured as a single line coming across the road and then splitting to service two homes. When the main shutoff valve to the meter or 'curb stop' failed, the only option was to upgrade to the current construction standards and create a separate service line.

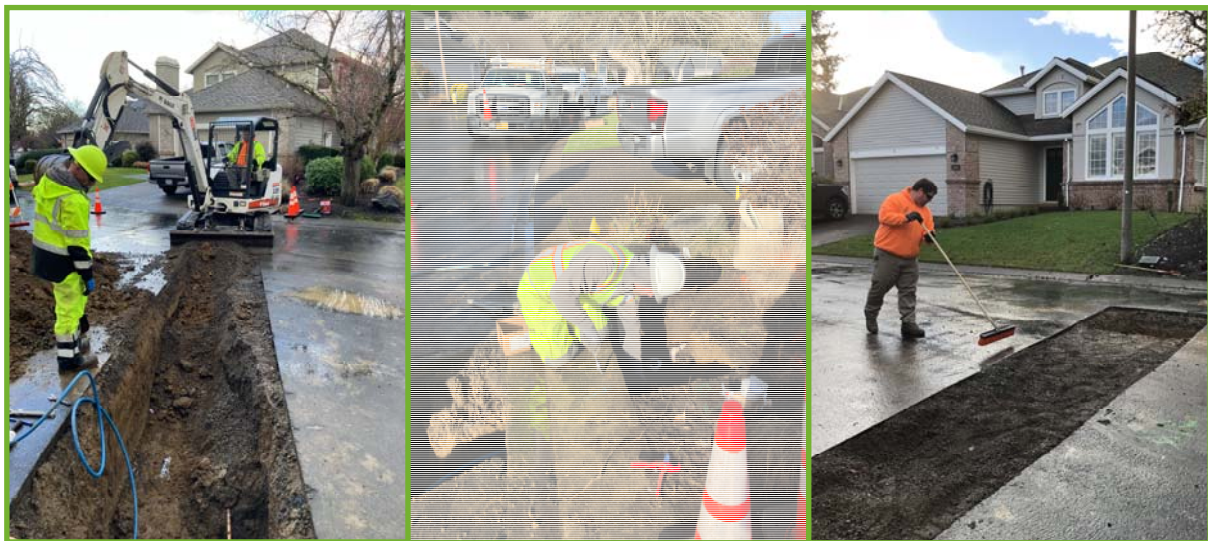
The water main was located on the opposite side of the street from the home, so a trench across the roadway was required. Staff excavated down to the main line and cleared the soil around the section to be 'tapped'. Staff drilled a hole into the water main using special equipment to install a corp stop valve and a new service line. Once the line was connected; the trench was backfilled and compacted in preparation for paving.

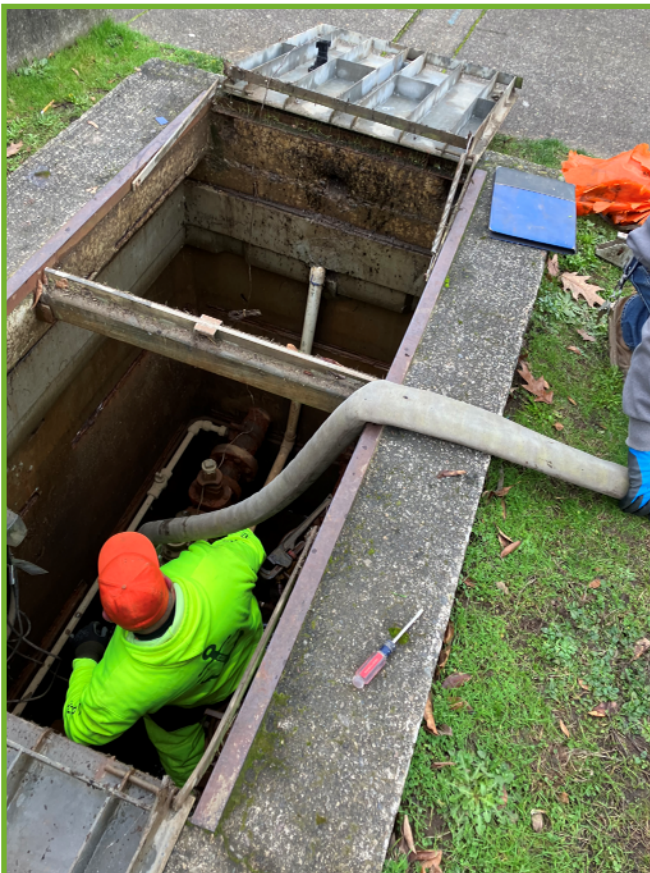
Accessing a commercial meter

The process for testing a meter consists of using a calibrated bench tested meter that the contractor provides. The calibrated meter is connected to the meter being tested. Water is run through both meters and compared for accuracy. If necessary the contractor performs any repairs or adjustments to the meter while on site. If the meter is not repairable it is scheduled to be replaced.

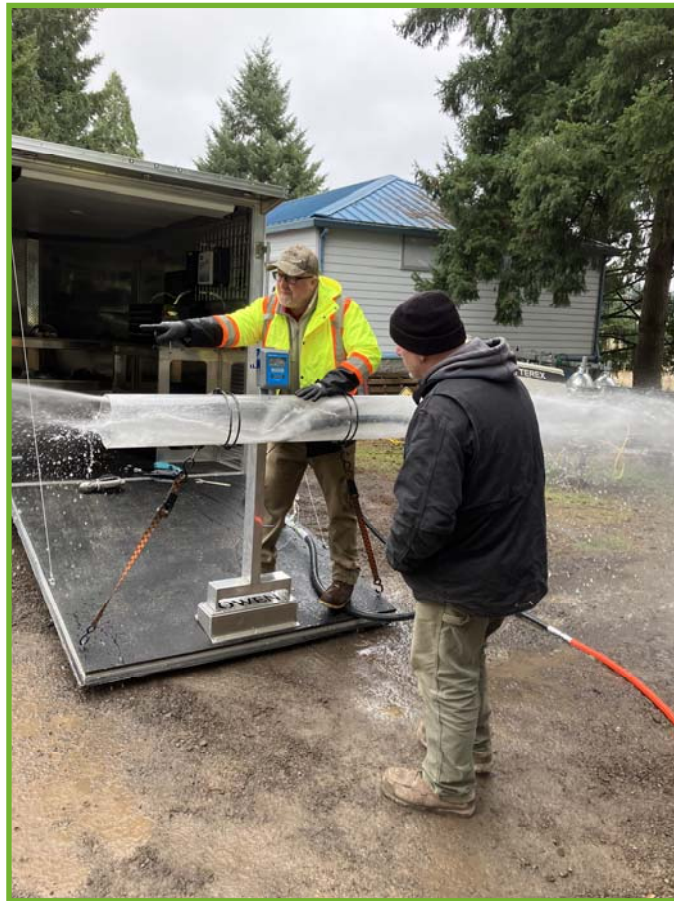
Wastewater and Stormwater staff attended a vendor demonstration of different nozzle options that can be utilized on the combination cleaning truck for cleaning stormwater and sewer lines. The demo was informative and allowed the operators to visually see the spray pattern of each nozzle through a transparent tube. The tube was equipped with a flow meter and pressure gauge allowing them to see how much water would be used with the various nozzles.

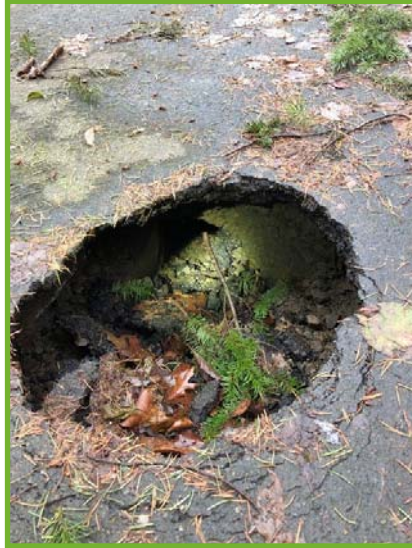
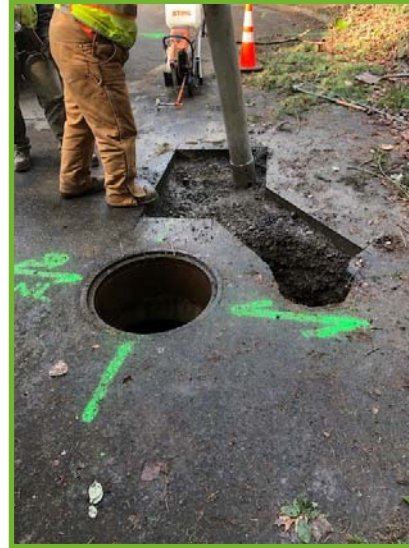
A citizen reported a sinkhole on St. Helens Drive. Further investigation confirmed the presence of a cavity in the asphalt in the cul-de-sac. Utilities staff responded to provide locate services and assistance with operation of the vacuum truck to remove soil to determine if a water or sewer service line was involved. The cause of the hole appears to be as a result of a failed stormwater manhole. The crew temporarily sealed the leak from the manhole and ensured the street is safe for pedestrians and vehicle traffic. Repairs are scheduled to be completed the first week of February.

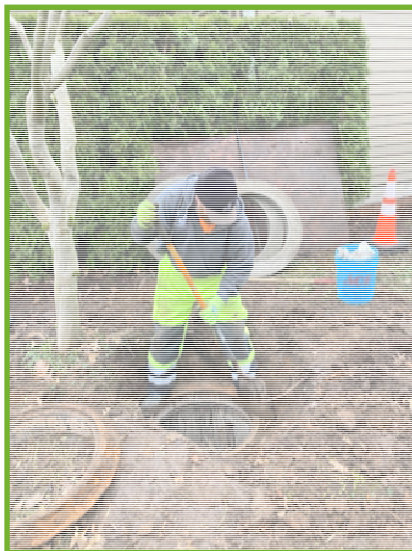
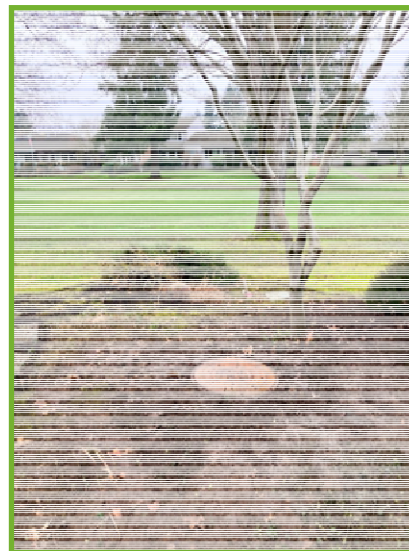
During routine cleaning of city inlets in Charbonneau, our crew discovered a sunken manhole that had been buried for a significant amount of time. Staff dug out the manhole, added a ring to lift the lid to the new height, and filled the soil back in.

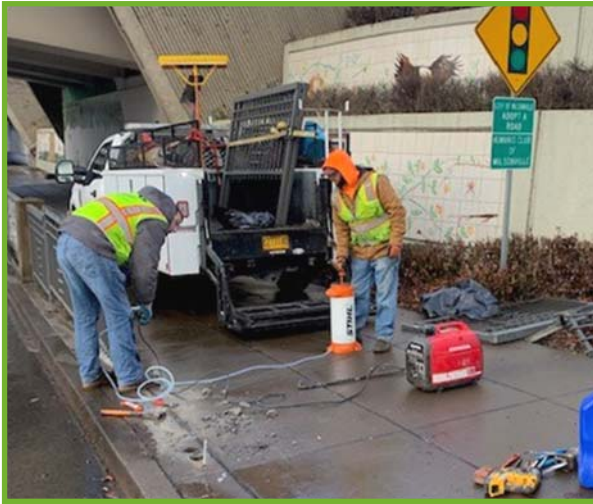
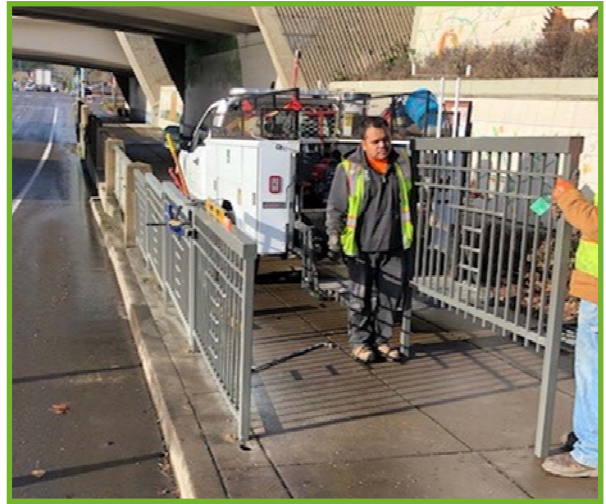
A recent traffic collision damaged the custom railing at the I-5 underpass. The panels are traffic collision rated to protect pedestrians while also providing a decorative flair. These panels are special order so our Roads team order more than was need for this repair to have them on hand for a quicker replace should the need arise.

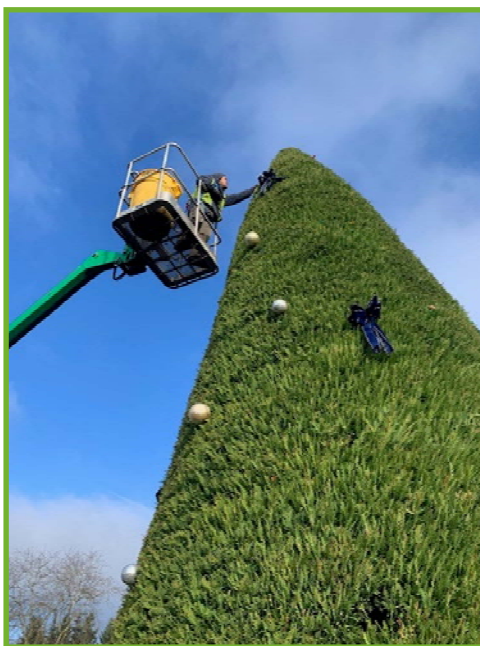
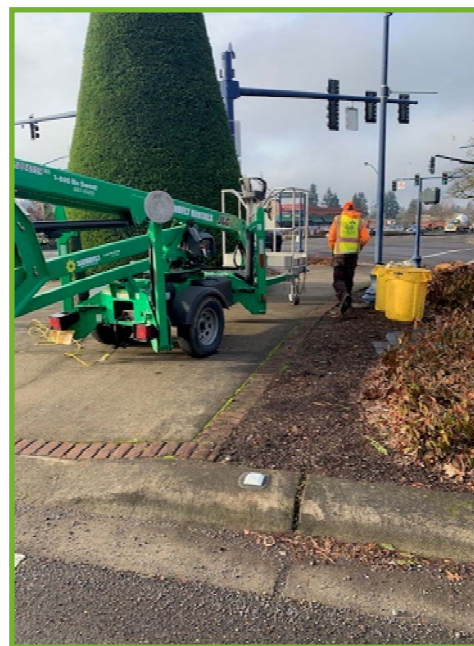
Saying “Until Next Time” to Winter Holiday Cheer

Roads staff completed the last few tasks to pack away the holiday decorations. The ornaments, ribbon and lights were taken down from the Leyland Cypress on Wilsonville Road at Boones Ferry Road using a 35 foot electric lift. Staff must gear up and tie in to complete this work—requiring special training and being comfortable working at approximately 30 feet over the ground.
